# Joining the Dots – 2020 Update

Problem Recognition, Research, Guidelines, Implementation, Reporting and Assurance

April 2020

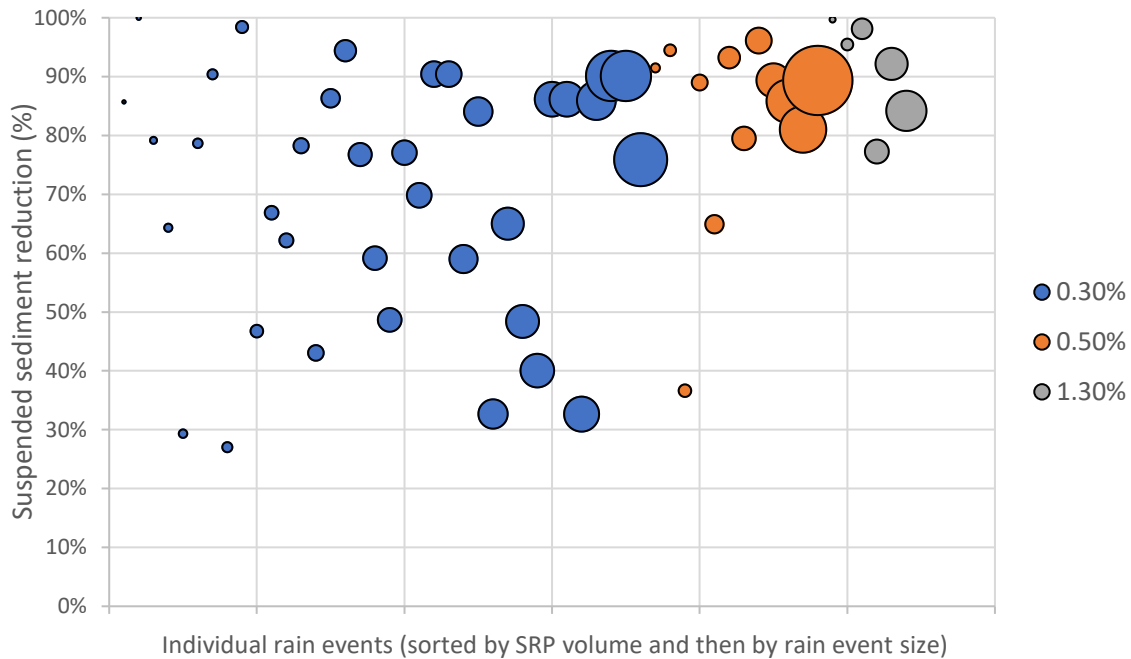
**Figure 2.** Summary of 4 years of SRP trials - proportion of suspended sediment removed by different sized SRPs. The colour of each bubble refers to the size of the SRP as a percentage of its catchment area, whilst the size of the bubble indicates the relative size of the rainfall event.

The main output of the project was understanding the effectiveness of different sized Sediment Retention Ponds (SRPs). The results are shown in Table 1 and Figure 2 below. These results supported the existing guideline (*Erosion & Sediment Control Guidelines for Vegetable Production*, Barber 2014) specifications for a minimum size of SRPs on cultivated horticultural land of 0.5% (50 m<sup>3</sup>/ha).

- The 0.5% SRP had an average total sediment reduction efficiency of 88%. The median suspended sediment concentration in the discharge water was 130 g/m<sup>3</sup>.

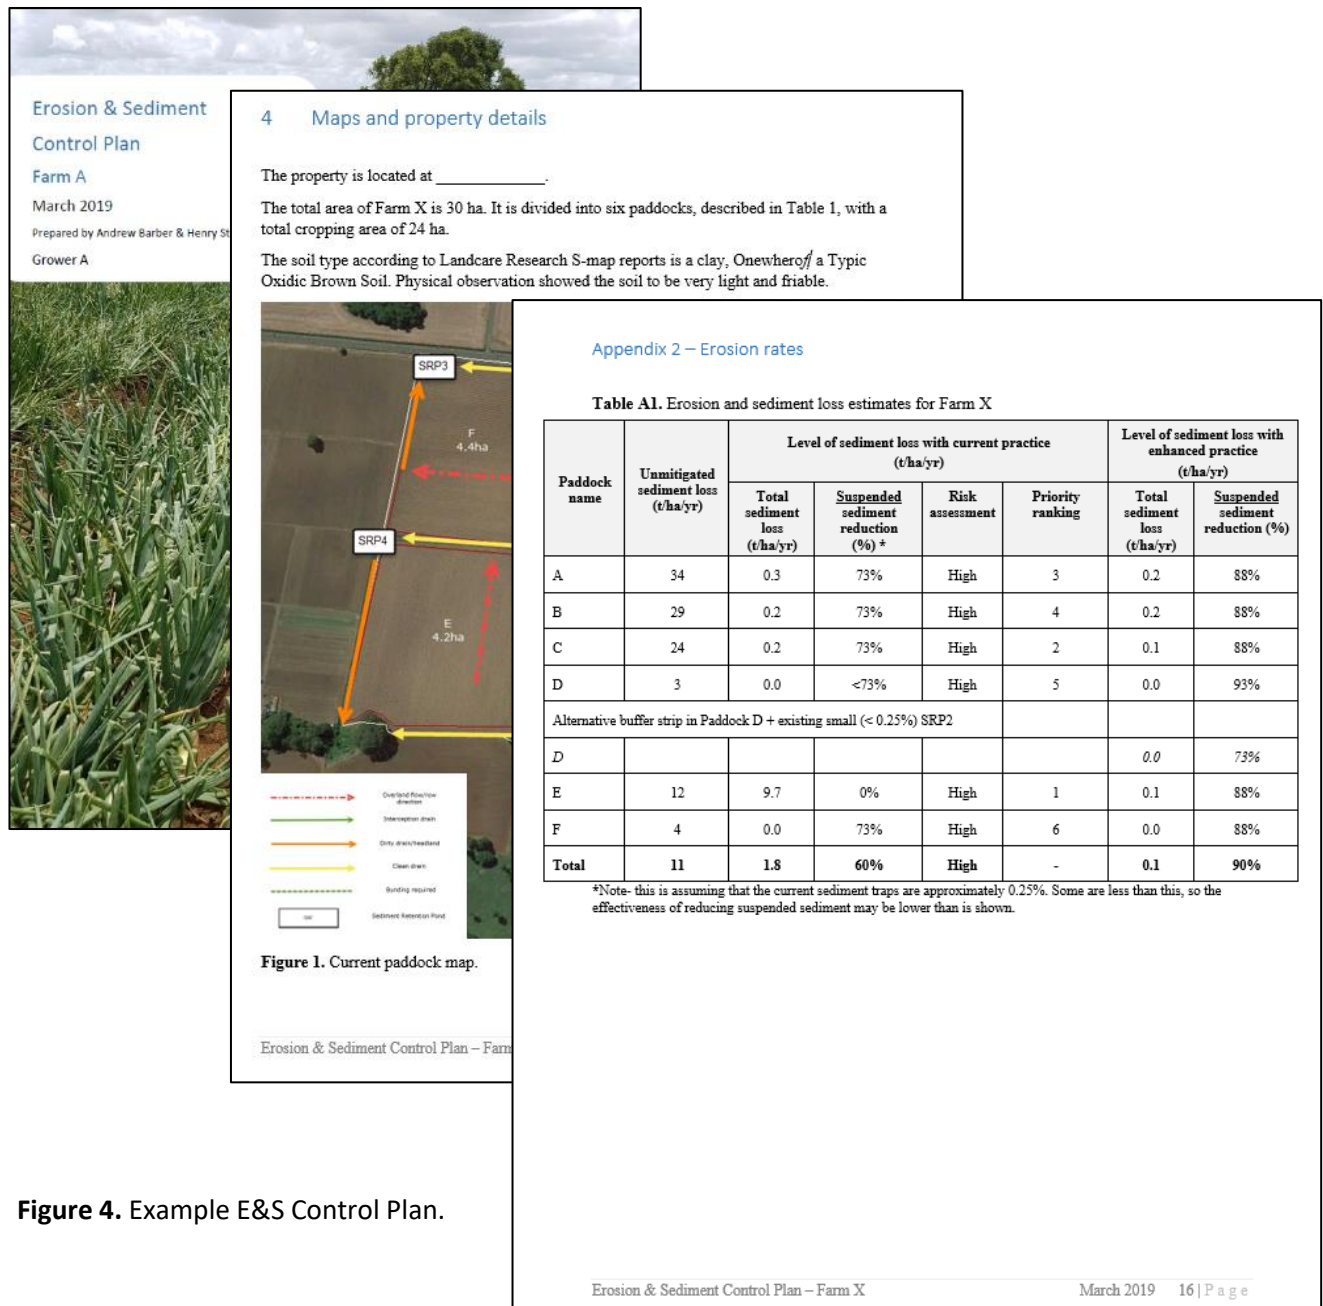
**Figure 4. Example E&S Control Plan.**

The case study E&S Control Plans went through multiple revisions in order to make them easy to use for the growers – and streamlined for auditing (see next section). The E&S Control Plan development process:

- 1) Beginning in late 2018, site inspections and Google Earth mapping of the site was used to draft the first report. NZGAP templates and other checklists from Horticulture New Zealand guidelines were used as part of the risk and mitigation assessments.
- 2) Further site inspections and visits which led to a streamlining of the report, as well as the creation of a short Construction Summary that can be provided to the machinery operators who are installing the mitigation measures.
- 3) During one of the site inspections an issue with one of the SRP outlets, with the road drain being too high to allow for enough volume in the SRP. This highlighted the need for a coordinated catchment-based approach between growers, their neighbours and council.
- 4) The E&S Control Plan was again modified and underwent an NZGAP audit, which identified further streamlining opportunities.

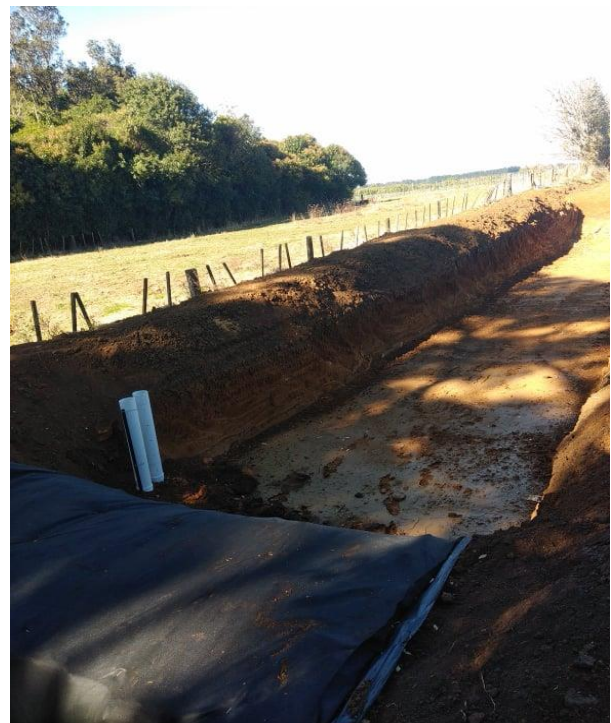
**Figure 6.** A completed 0.5% SRP. The important elements being volume, snorkels, and a protected level emergency spillway.

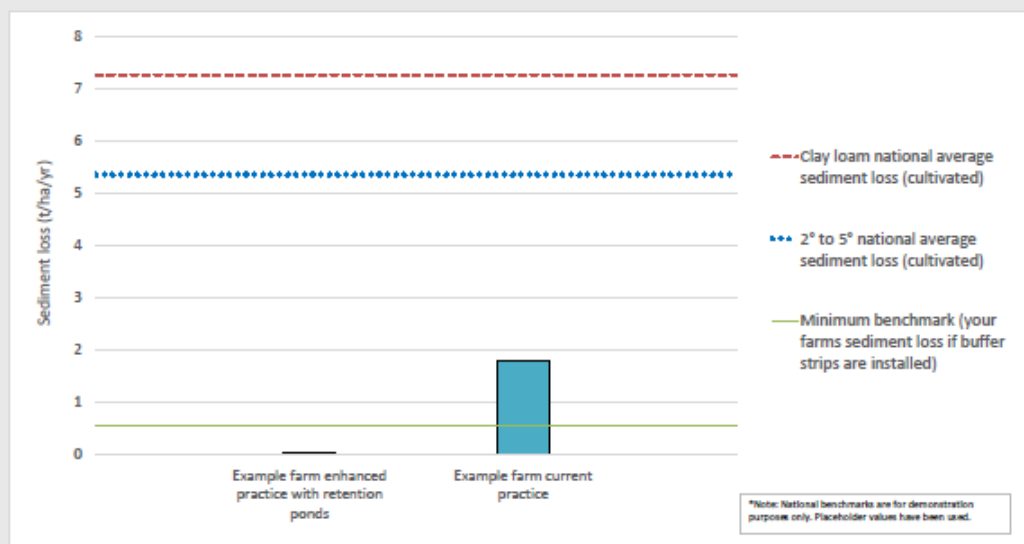
**Figure 8.** Individualised E&S Control benchmarking report.

Individualised erosion and sediment benchmarking reports have been developed. The reports are generated in Excel and exported as individualised 1-page pdfs.

Paddock descriptions, GMPs, and erosion and sediment loss rates are imported into Excel as a csv file, having been (at this stage) exported from Formstack. Grower details are imported from the NZGAP database.

The metrics used in the report include unmitigated erosion rates, along with current and future enhanced practice sediment loss rates. Enhanced practice is based on the use of cover crops, wheel track ripping, vegetated buffer strips or SRPs. The benchmarks are tuned for slope, location, and soil type. There is a link in the report through to the E&S Control Guidelines on the HortNZ website.

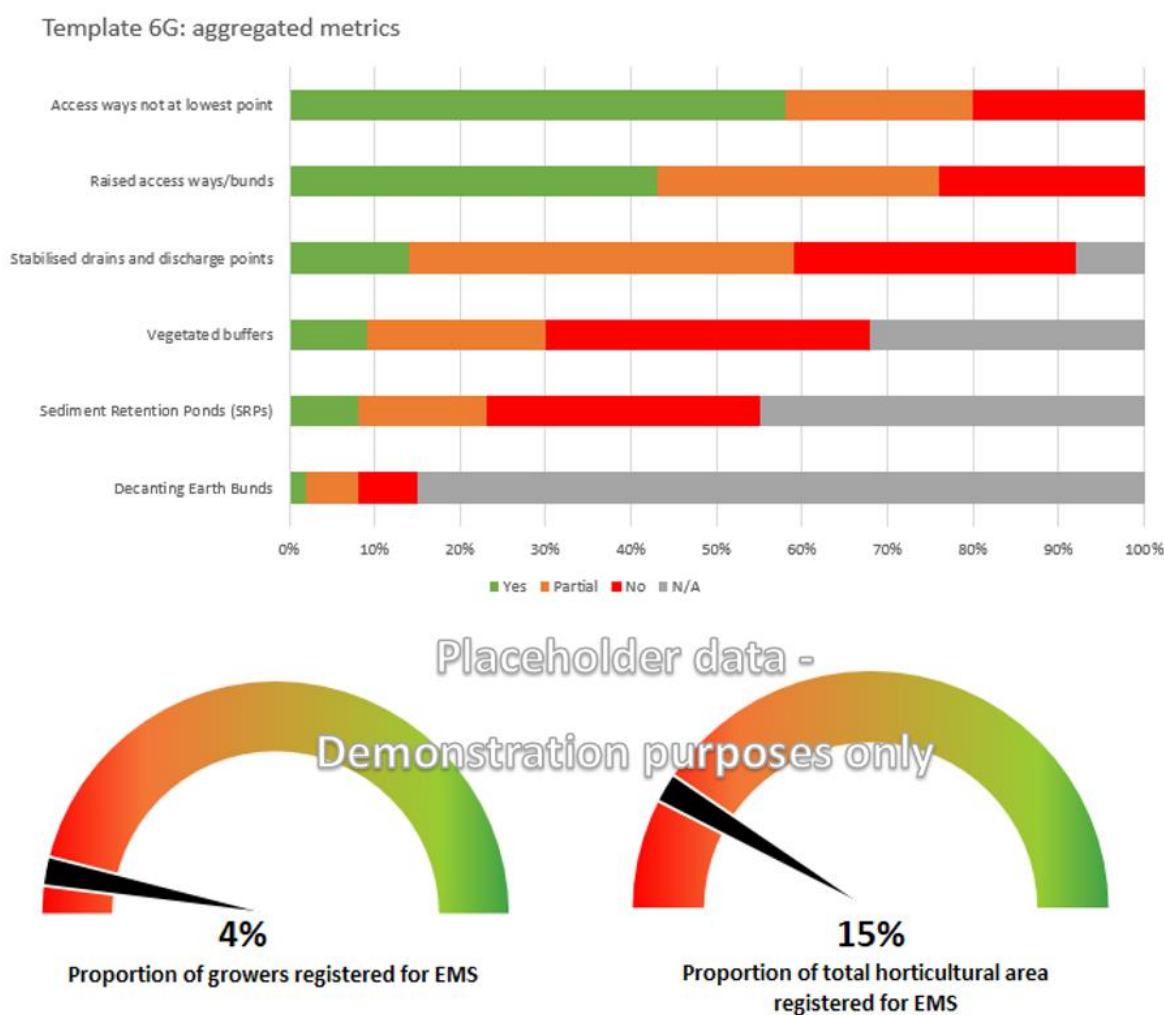
**Figure 9.** Dashboard report showing the aggregated adoption of sediment control measures to manage the water and suspended solids that move off paddocks.

Figure 9 shows an example of what aggregated E&S Control GMP data could look like.

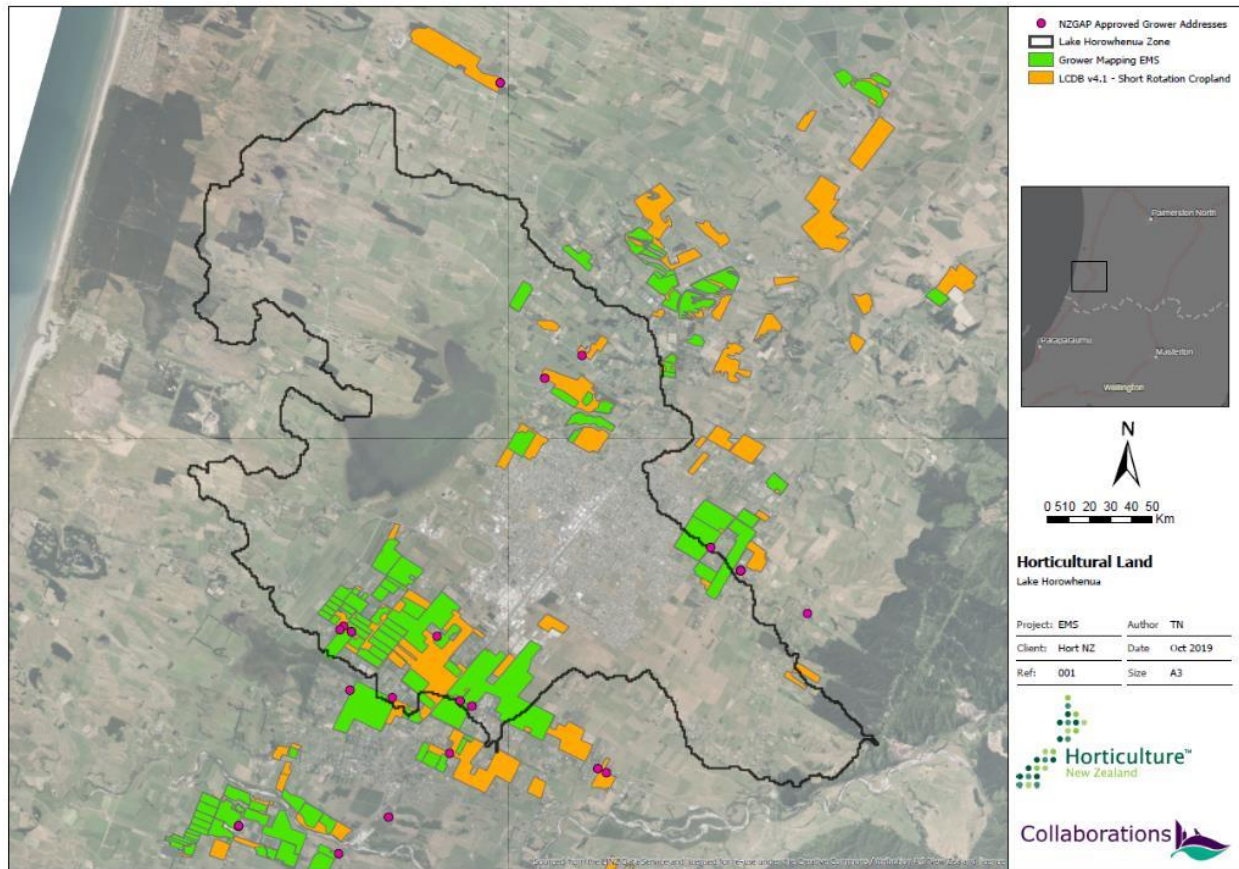
**Figure 10.** Vegetable cropping land in Levin with a complete or partial EMS in green and the balance of the vegetable cropping land in orange

The maps were collected and entered into Google MyMaps, and then imported into ArcGIS. Whilst extremely time consuming, this process enabled a catchment analysis across the entire industry in the Lake Horowhenua catchment. The maps, in conjunction with the Don't Muddy the Water App, were used to calculate erosion rates across 1,090 ha, comprising of 22 operations and 263 paddocks.
